Near Surface Geophysics Innovations, LLC

Using Electrical Resistivity to Locate an Uncontained Diesel Plume

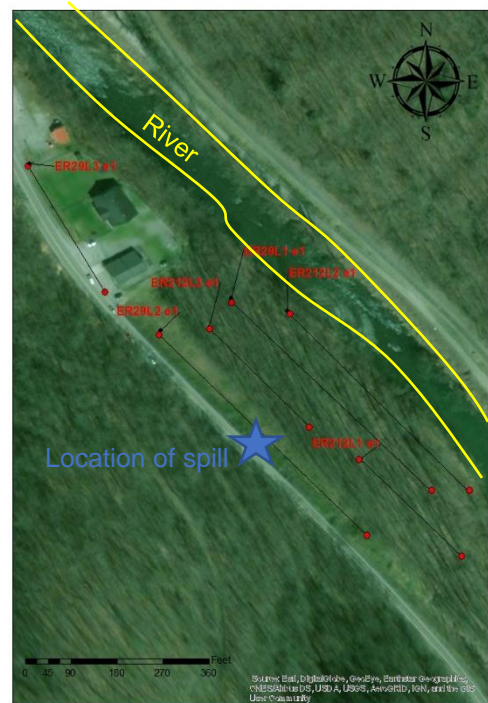
Figure 1. Map showing the layout of the ER surveys trending SE to NW. These types of maps are constructed, geolocated and projected using ArcGIS and sent to our clients. The blue star indicates the spill site and the river is outlined in yellow.

Approach: NSG Innovations suggested running parallel (Figure 1) electrical resistivity (ER) survey lines between the road and the river. Establishing the ER lines parallel to the road was decided to be the best approach for intercepting potential subsurface migration diesel-plume pathways from the spill location (star) to the river. ER was the chosen methodology because such surveys detect a wide array of physical properties of materials and thus can be used to map a wide range of different materials. A variety of types of sediments and bedrock, the saturated zone, as well as signatures of the diesel plume could all be identified using ER.

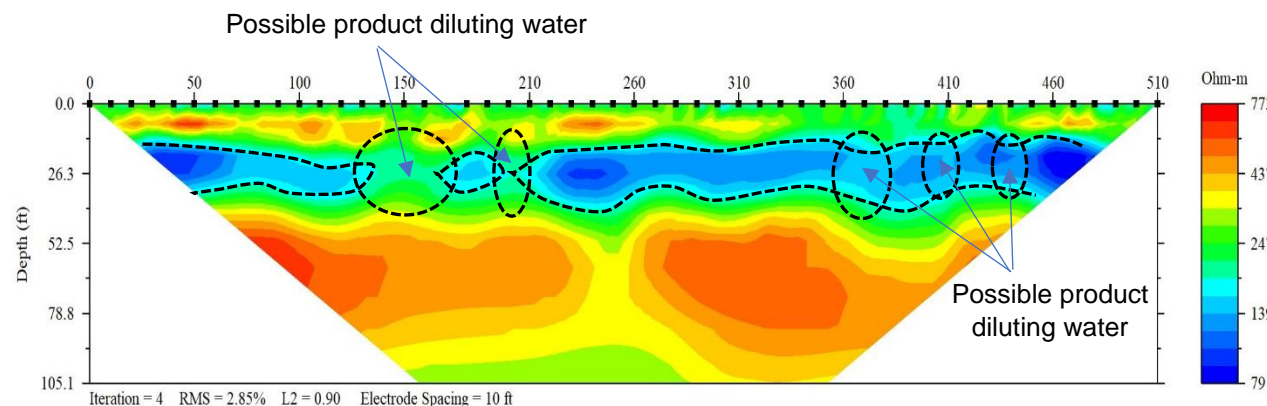
Figure 2. The above image is an example of an electrical resistivity cross section from the project. Such an ER survey permits characterization of subsurface features and designates possible locations of the diesel (product) spill plume.

Survey Results: Interpretations (Figure 2) for locating the diesel plume worked off two principles: 1) all hydrocarbons are non-polar molecules and thus they are resistive to electrical current and 2) diesel is an LNAPL and will be notably floating atop the saturated zone in the sandy river (fluvial) alluvial deposits. Based on these two principles, the expected observation would be a decrease in conductivity at or above the saturated zone. The dashed ellipses in the cross section above (Figure 2) indicate the expected signatures in this scenario and were picked as targets to be investigated with a direct-push technology boring program at the site.

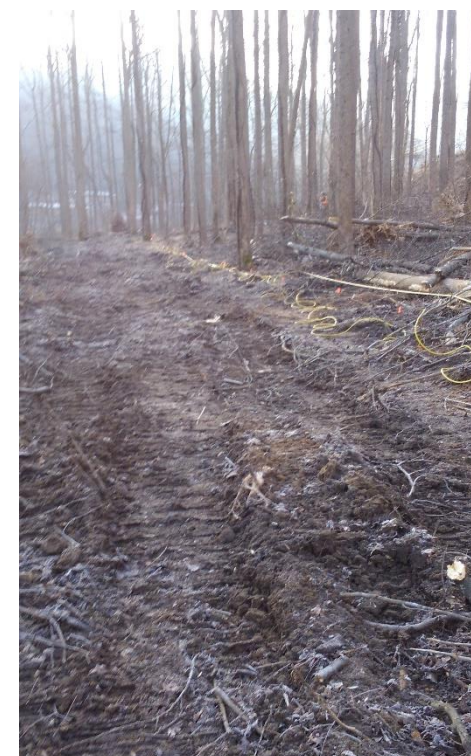
Figure 3. Image showing the site conditions as well as an ER line traversing from the top of the image to the right. Trees were felled to permit some access for geophysical surveys and heavy equipment operators for excavation.
